# Vaucluse Diamond Bay Ocean Discharges

Pollution Study Report (PRP 305)

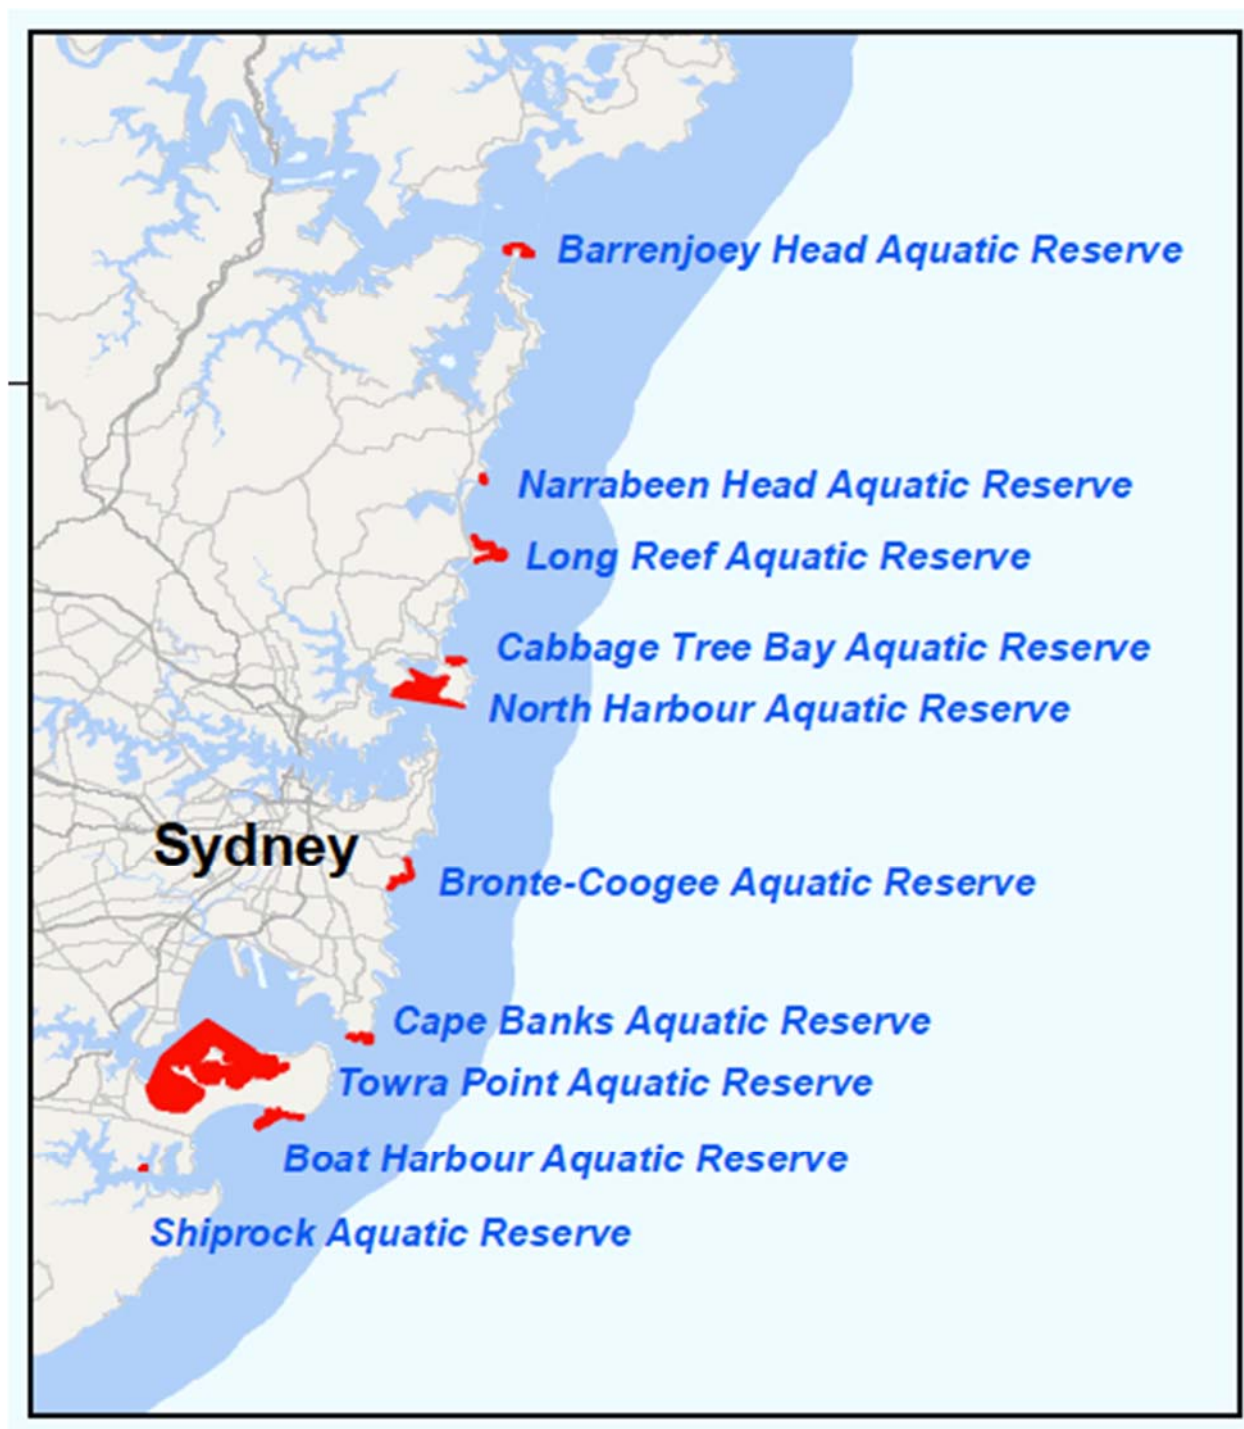
**Figure 5-7** Excerpt from NSW marine protected areas map (source: NSW DPI)

The nearest marine protected areas are North Harbour, Cabbage Tree Bay (Manly), and Bronte-Coogee but there is no evidence of impact from the outfalls (**Figure 5-7**).

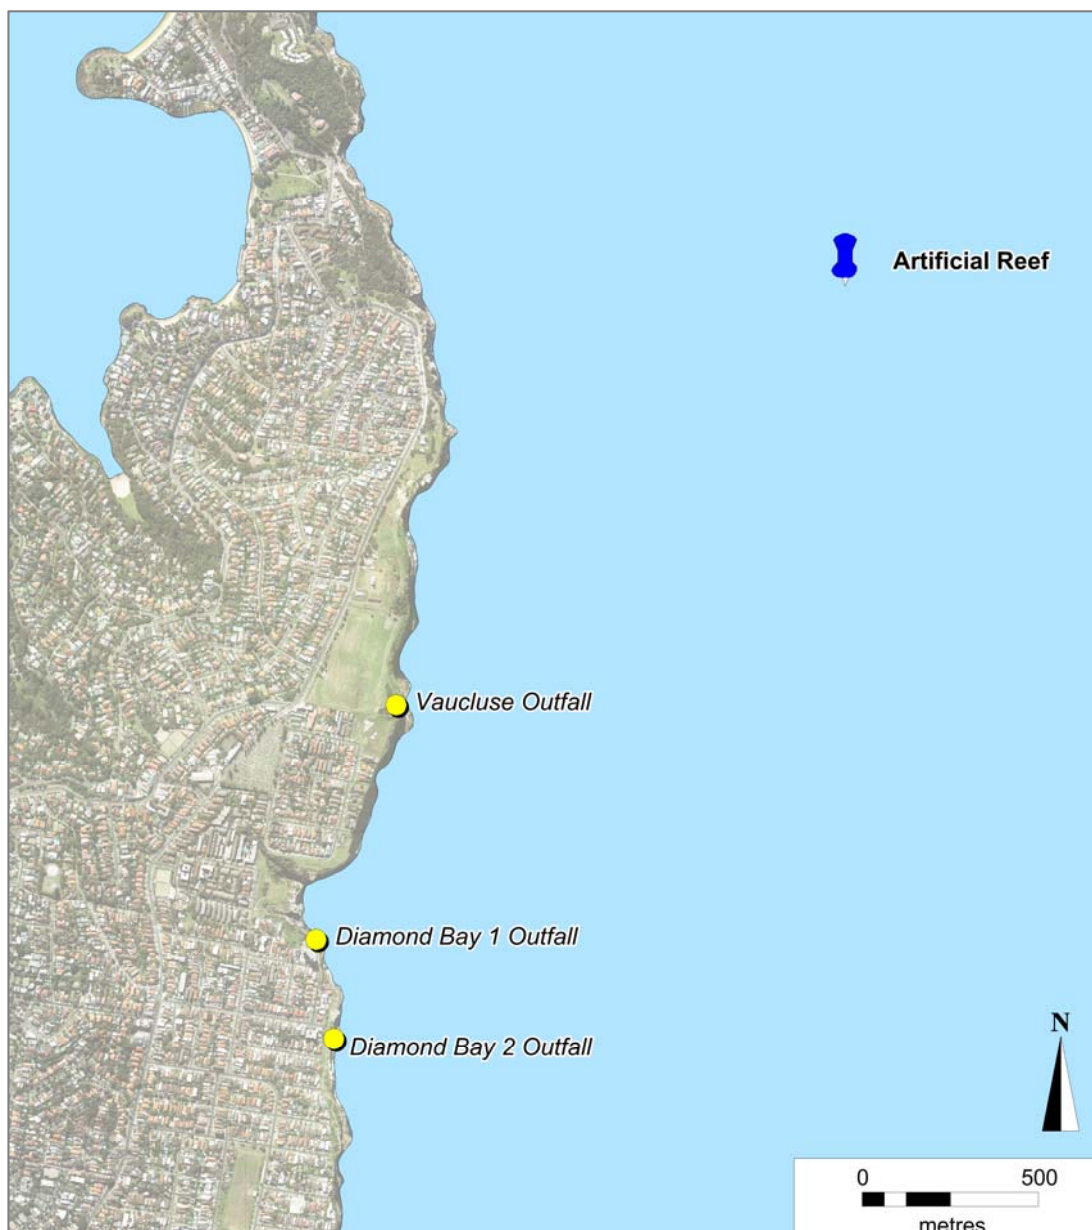
**Figure 5-8** Location of Vacluse artificial reef (deployed by DPI Fisheries), in relation to the VDB outfalls.

Sydney's first artificial reef was deployed off the coast of Vacluse on 12 October 2011 by the NSW Department of Primary Industries (DPI). The project was funded by the NSW Recreational Fishing Trust. It is located about 1.2 km off the coast from The Gap at 38 m depth (see **Figure 5-8**).

The nearest VDB outfall to the reef is Vacluse, located about 1.8 km southeast. At this distance, it is considered unlikely that the discharges from the outfall would adversely affect the water quality or ecosystem at the artificial reef site. The location of the reef is outside of the Category B, C, and D areas modelled in the pilot modelling (see section 5.4.3).
